LAND AT BRANCEPETH

Heritage Benefits

Simpson & Brown
June 2016

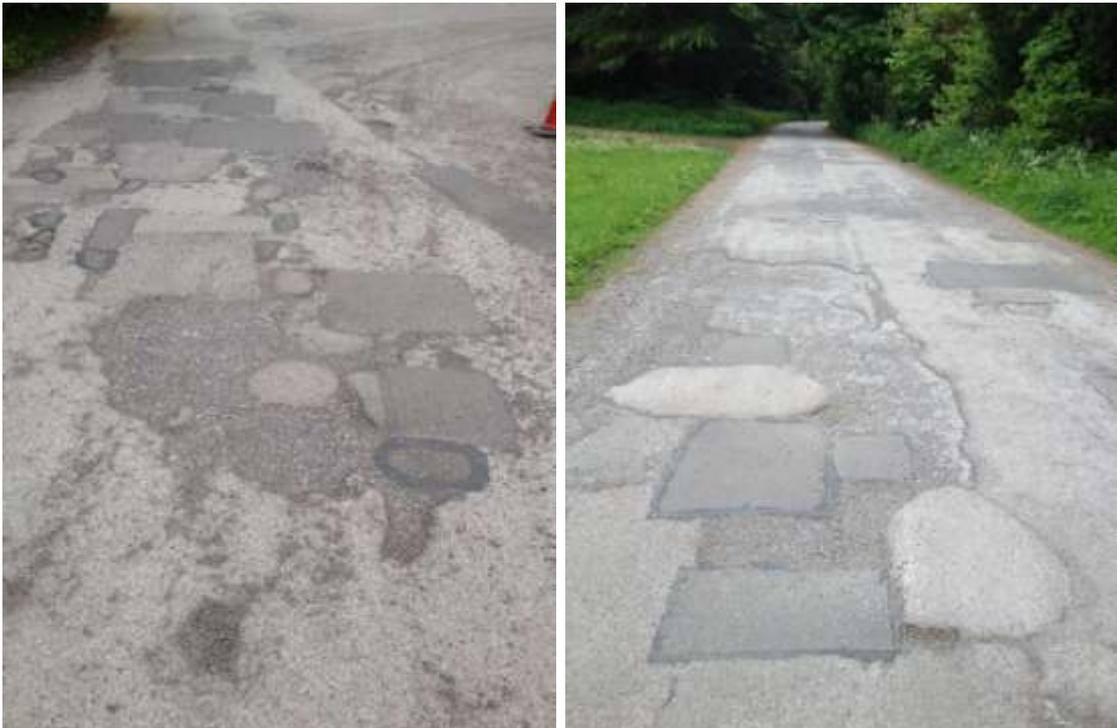
- 1.1 The driveway itself does not look good mainly because of its condition and materials. It is a tarmac road which has been patched many times and still has potholes. This driveway is the route to St Brandon's church. The church is an important historic building and even though it lost a lot of its historic significance in the fire, the way that the church has been repaired following the fire makes it a beautiful interior and a beautiful place. This route between The Village, past the castle to the church could be made to look better by a new surface on the road. Ideally, this should be bitumen-bound gravel. It must be laid at the right time of the year to be effective but, ideally, the character of the approach should be of a gravel drive with soft edges to the verges.

Planting should be allowed to grow over the edges but define the drive with a reasonably straight line. The current vegetation along the edge is weeds and nettles with some rhododendrons. More specimen planting and more flowers would improve the character of this approach.

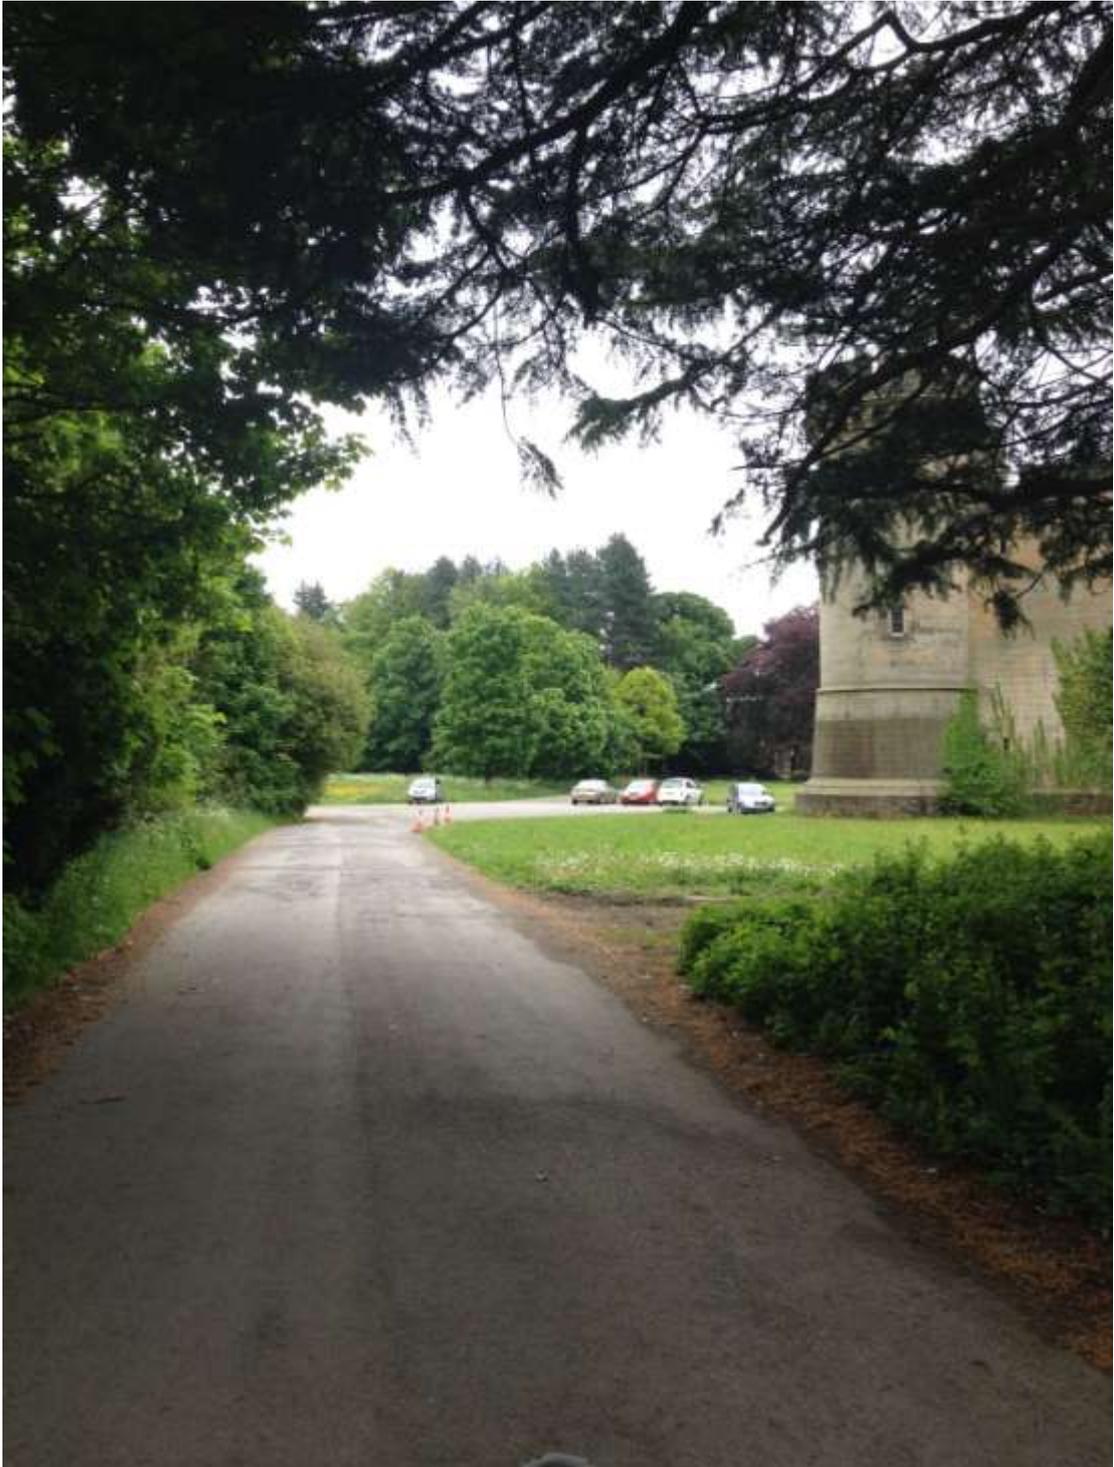
- 1.2** The area in front of the Gate House would also benefit from a more carefully defined area of bitumen-bound gravel. The areas between the drive and the gate house is grass covered with dandelions and some weeds. This is broadly appropriate and the appearance of the area would be improved by a better road surface.

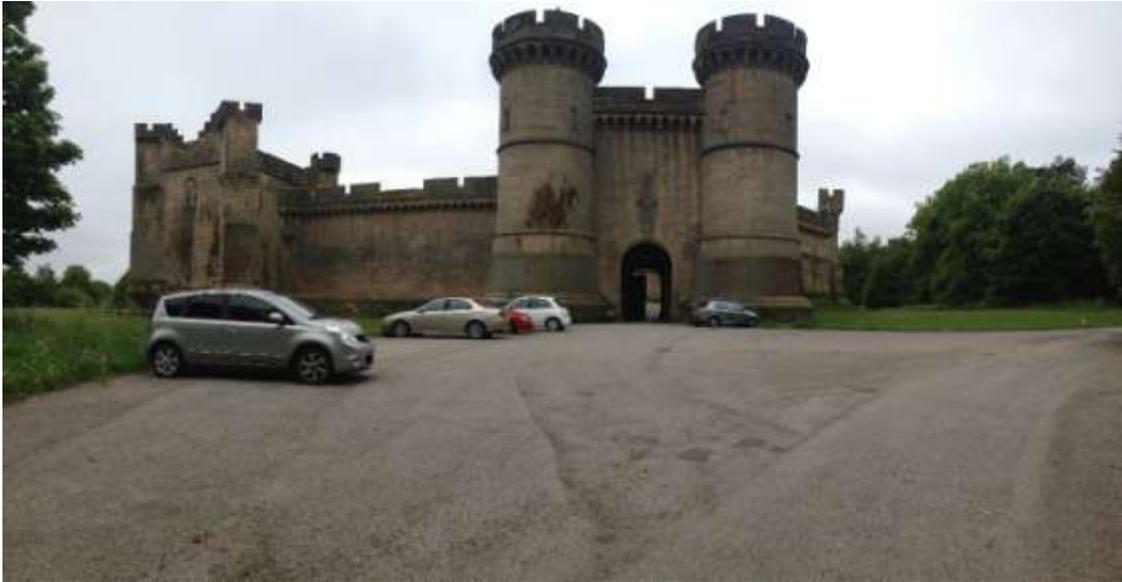
- 1.3** However, the strongest improvement that could be made would be to relocate the car parking away from the front of the Gate House. Cars spoil the relationship between the gateway, the castle gate house and the church.

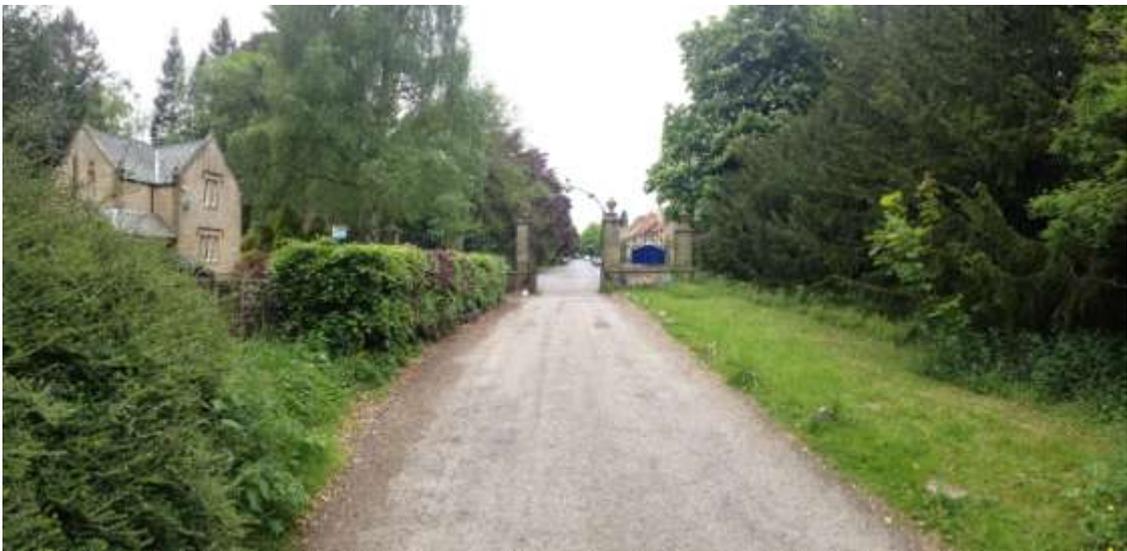
Cars parked in random positions block the view along the route towards the gateway to the church graveyard. It might be possible to relocate parking to an area to the east that is screened behind trees. It could be next to the route to the church or within the woodland directly to the east of the gate house.

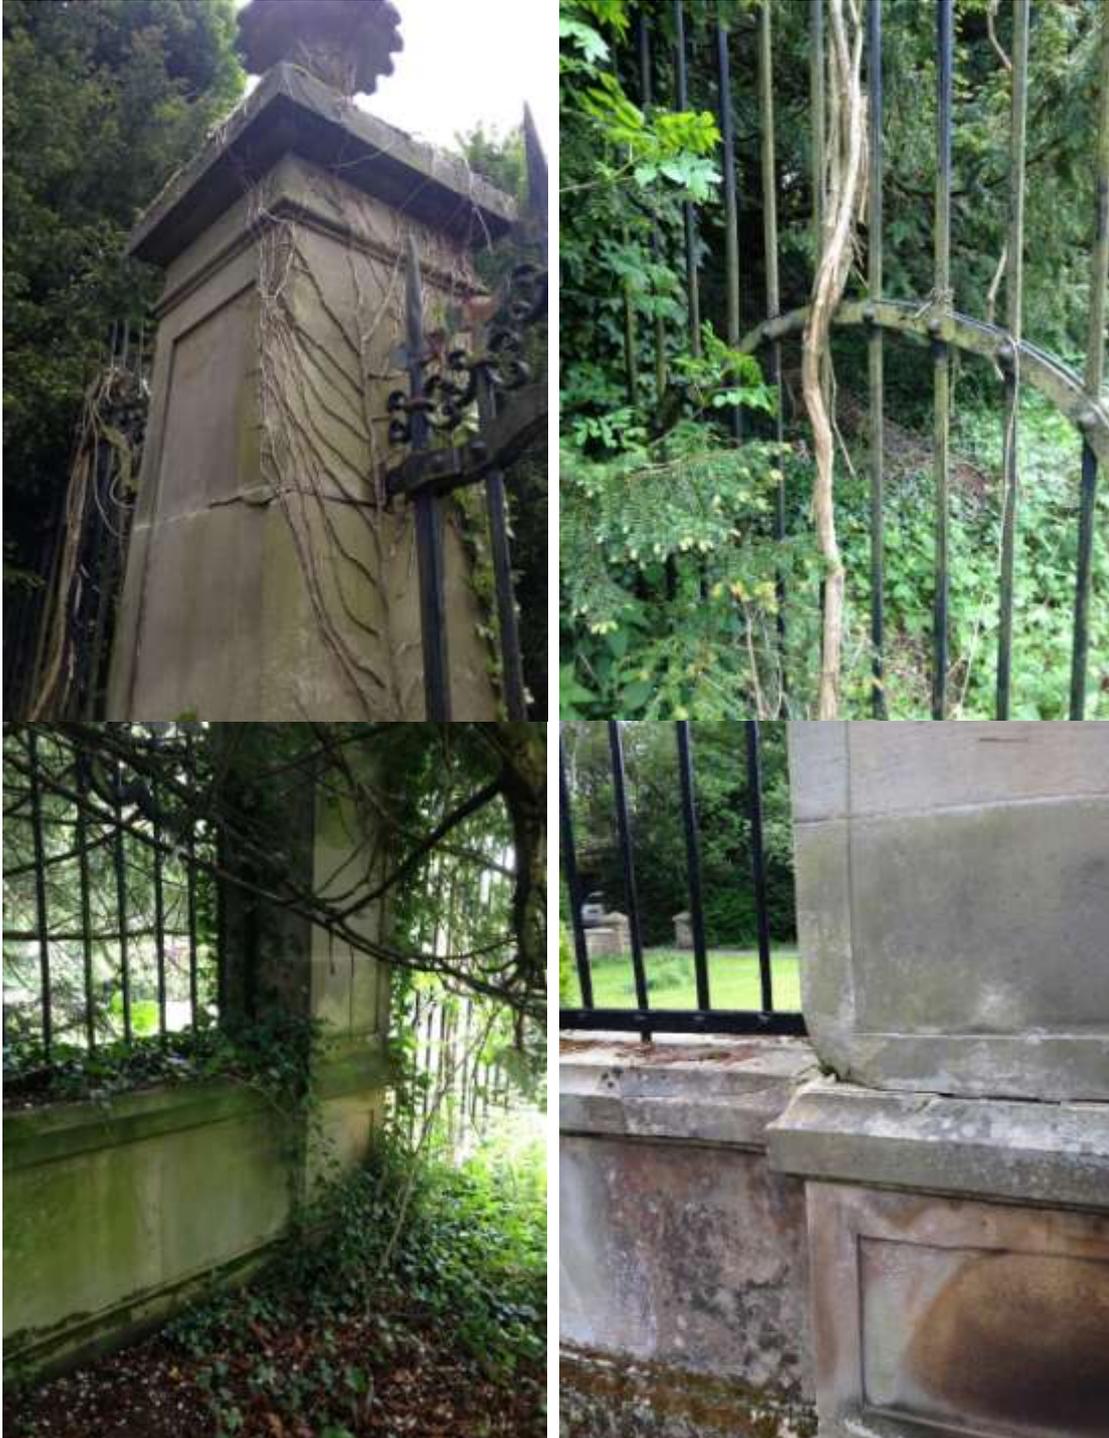
The gate screen is a symmetrical arrangement around the central gate with side gates in a seven bay arrangement. The central gates appear to be the original ones. The notice board for the church that is fitted to the railings detracts from the overall quality of the gates and would be better as separate notice board mounted on timber or metal posts.

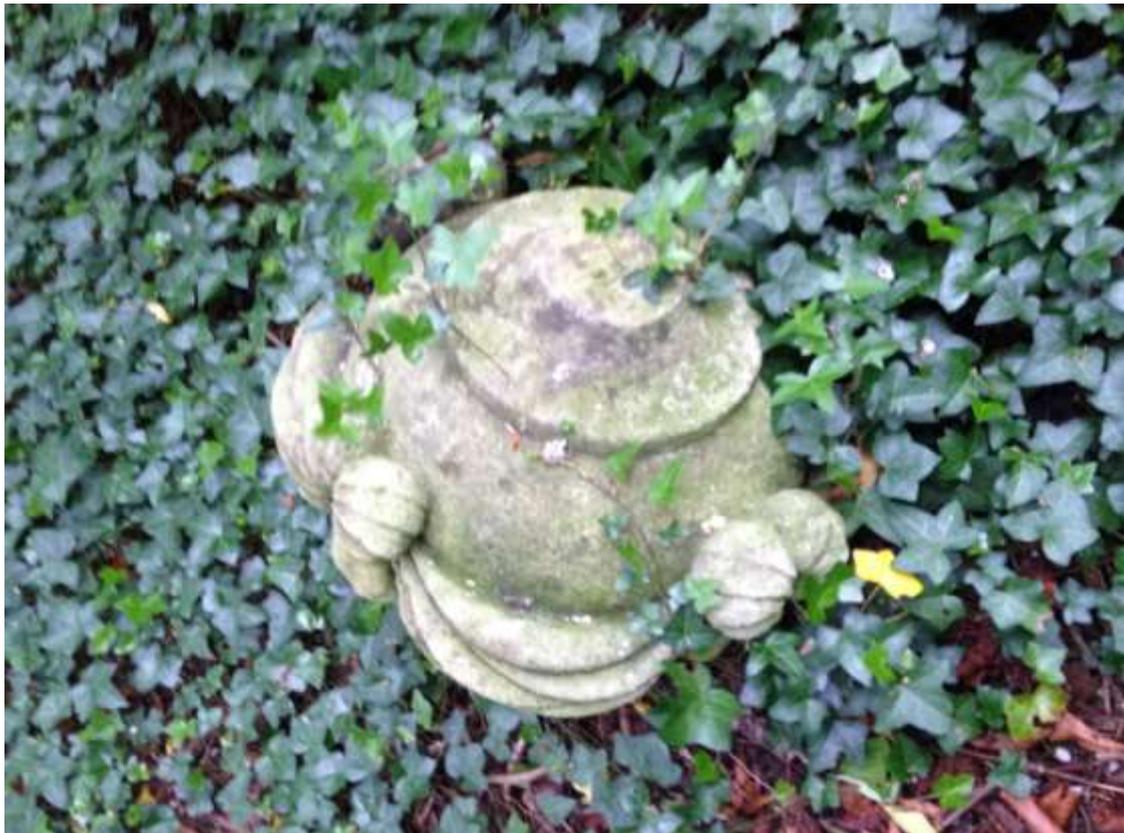
The urn from the pier is lying on the ground on the south side of the railings. It will need a new top knot carved stone and specialist conservation. Oddly, it does not match the two urns on the west side gate, so it might have been an urn from the end pier.

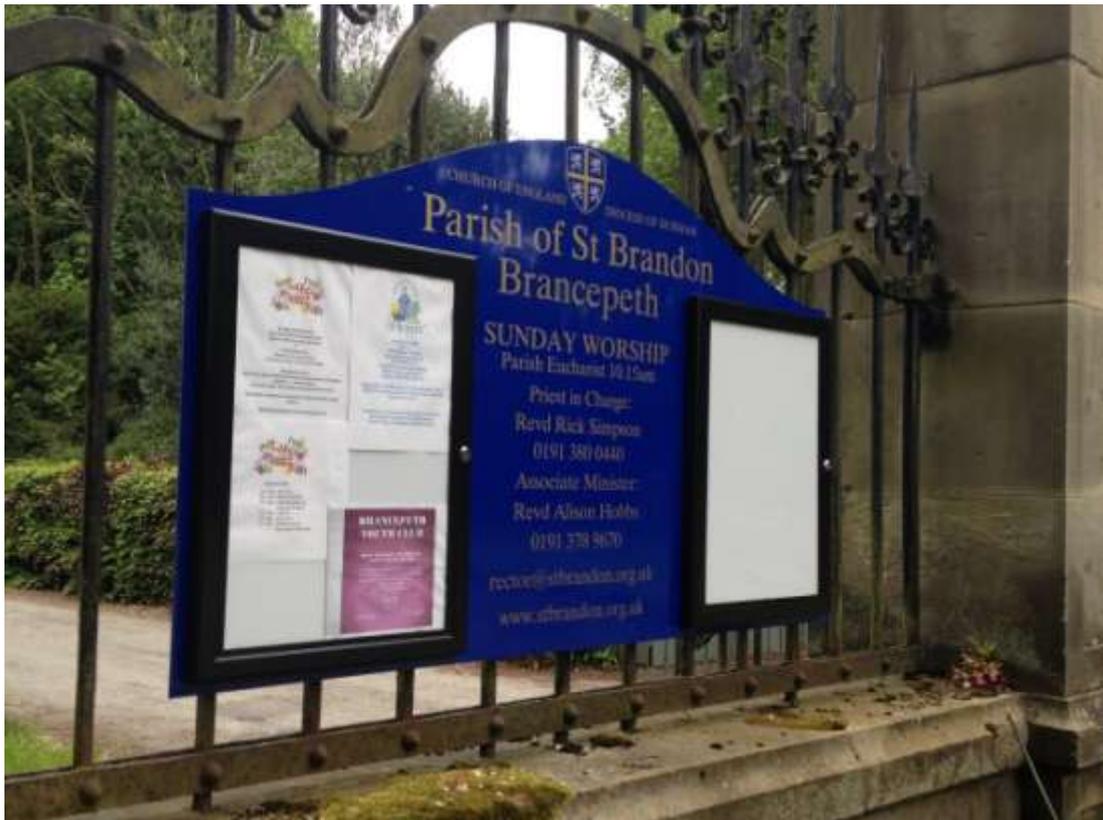
- 2.6 East central bay – this has railings above a stone riser.

One spear head is broken and needs to be repaired.

Remove and relocate church sign.

Remove moss from riser and include some pointing.

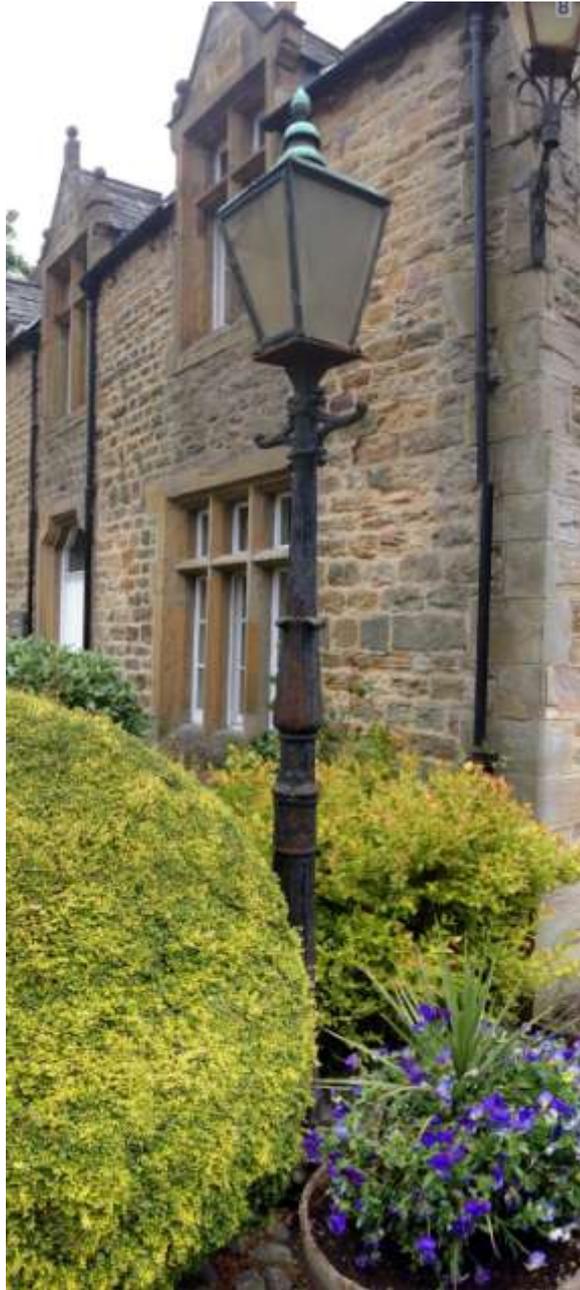
- 3.1 At the junction with the main road is a single street light which is in poor condition and could be wire brushed and repainted.

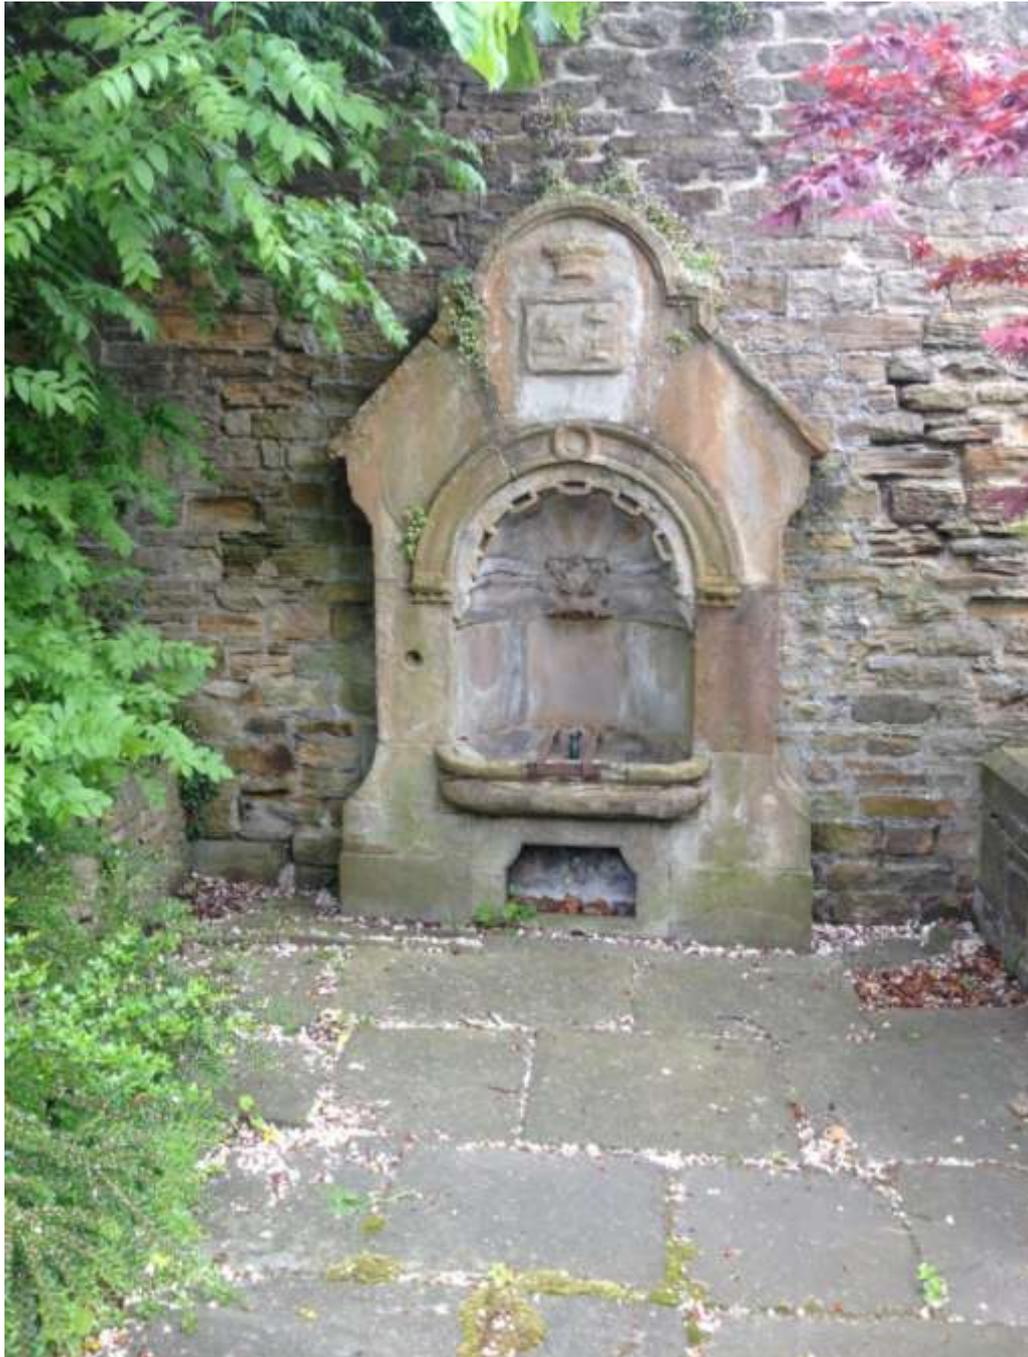
- 3.2 The well could be repointed with some conservator work to the shell. The iron bands over the head of the bowl should be wire brushed and repainted. Joints should be raked out and repointed. Chickweed removed. The area of paving in front of the well could be re-laid with better drainage. To the east and west of the well are areas of rubble wall about 2 sq. m each which should be repointed.
